Date: February 16, 2005

Subject: Shadowfax Run Subdivision
Jackson Avenue, New Windsor

Reference: January 14th flood conditions
In area of road

Memo by: Drew Kartiganer for
Shadowfax Run and
Tiger Lilly Development

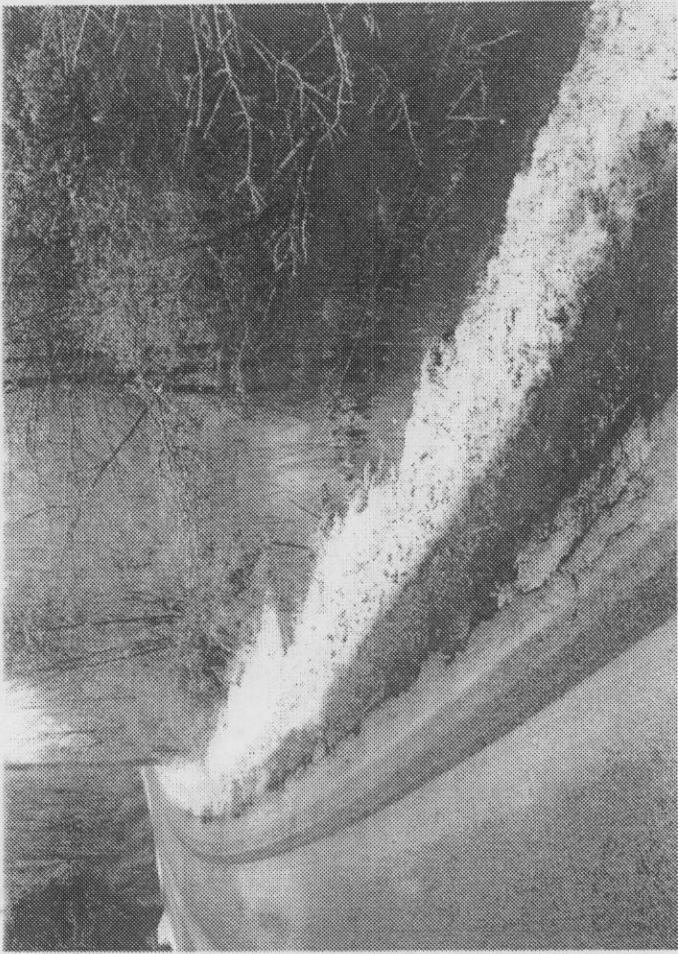
Flow WATER, PART SIDE AT P. BRIDGE

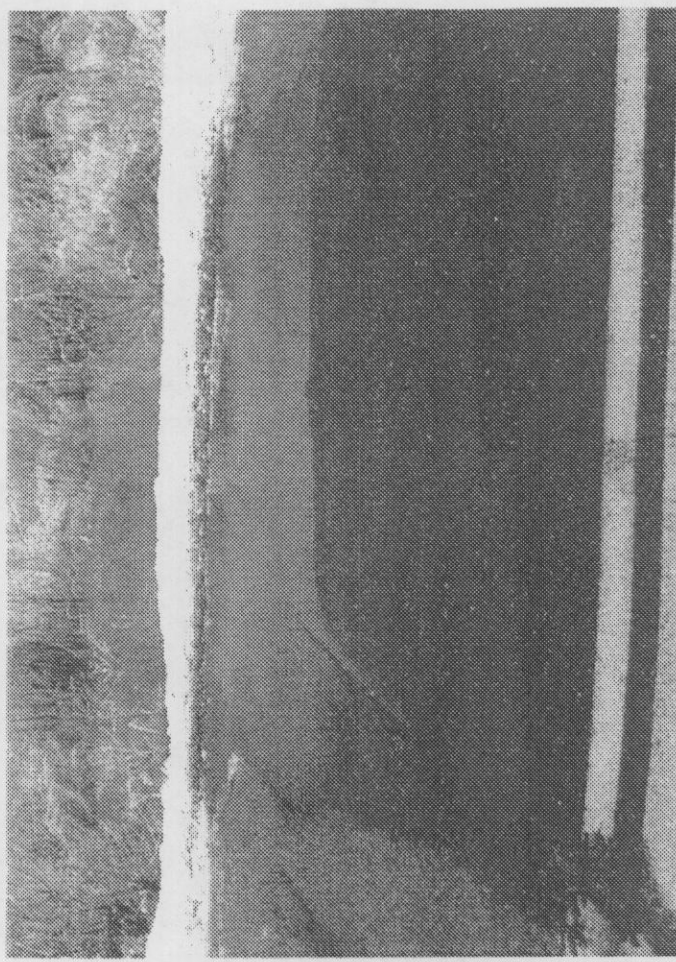
A,B, are back water on east side of bridge (development side)

B is photo of backwater to EAST side of Jackson Ave. reference point of speed limit sign and truck was established to mark location of culvert which is in between the two. It should be noted there is no current or flow of water from the culvert demonstrated in this picture .

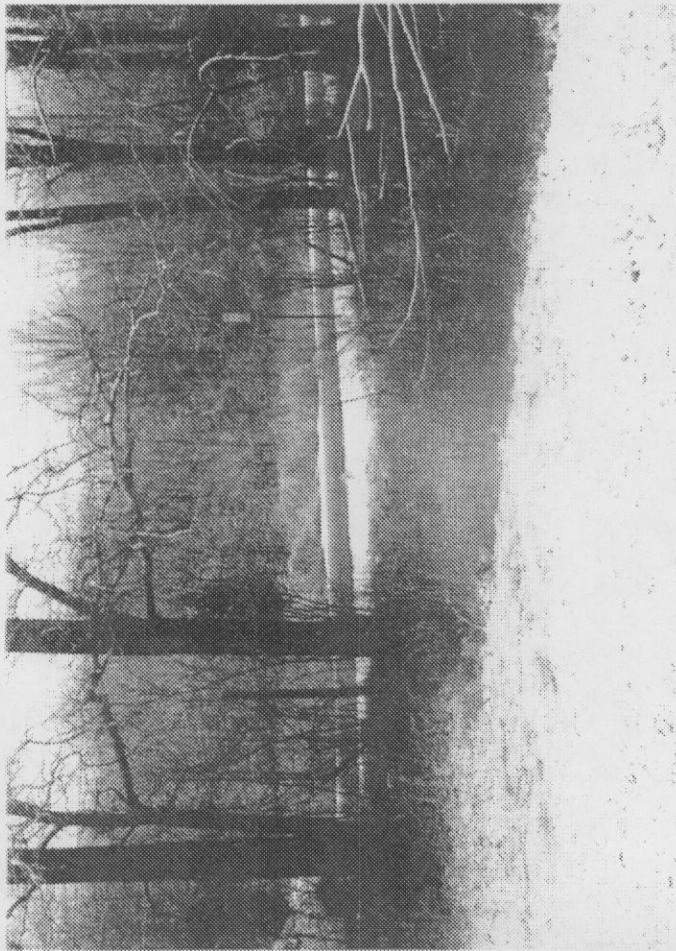
These Photographs were taken at the bridge near the top of Shadowfax Development site along Jackson Ave and show the "back water" conditions on the east side of the bridge and full water flow on the west side. The backwater condition on the east side of the road demonstrates that there is not sufficient release of water at the Bridge area to accommodate storm water release from the drainage basin that feeds this stream bed above the bridge.

A is photo of backwater conditions on east side of bridge and
